Case Studies: **Picote Dual Color Epoxy Coating**

ASTM and NSF Certified (meets the requirements of NSF/ANSI 61-5).

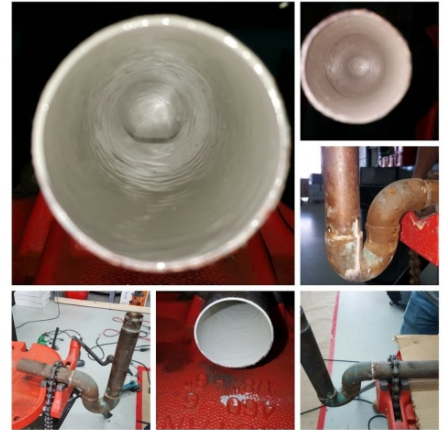
Condo building, Chicago, IL (2016)

40th floor rooftop pool was leaking into the unit below which was a music studio. A Gold Coast high rise was desperate to find a solution to fix the 1-1/4" through 2" steel piping to their pool supply and return lines. It had deteriorated over the years and was leaking badly with no visible sign of failure on CCTV. Three coats of Picote Dual Color Epoxy were applied.

Benefit: The system was able to navigate multiple bends even in the smallest pipe to seal all leaks.

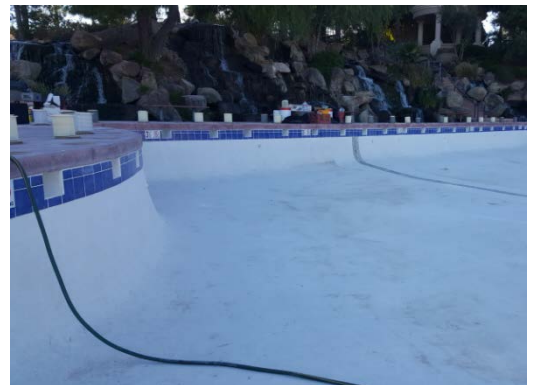
Resort, Phoenix, AZ (2017)

Coated 1 1/4" swimming pool line with three coats, including pool skimmers and discharge lines. Sealed leaking skimmers that were badly cracked. Contractor was able to avoid breaking up pool deck at each skimmer for replacement.

Benefit: Epoxy suitable for heavily chlorinated water.

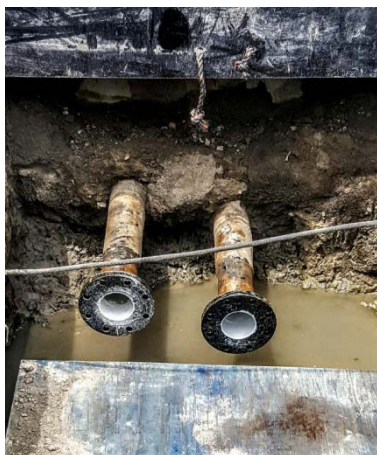
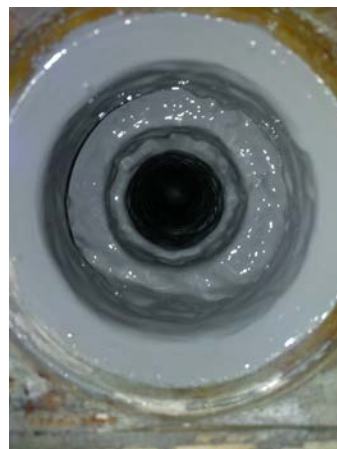
Office Building, Chicago suburb, IL (2017)

A large campus for a major insurance company was experiencing reduced flow in their 8" fire suppression main due to heavy tuberculation build up in the pipe. After cleaning the owners wanted to seal the pipe to prevent this problem in the future. High pressure and flow requirements along with 90 degree bends made CIPP repairs impossible.

Benefit: Sealed off heavily corroded main and was able to navigate multiple bends.
